**Flood Control Project Maintenance  
Levee Inspections**

## Maintenance Issue Types Only, Levee Inspection Report By Mile - Spring 2017

### Reclamation District No. 0108 River Farms

Waterway	Bank	Unit Miles	Inspection Start/End	Inspector
Unit No. 01 Colusa Basin Drain	Left	20.64	05/03/2017 05/03/2017	Zach Jojola

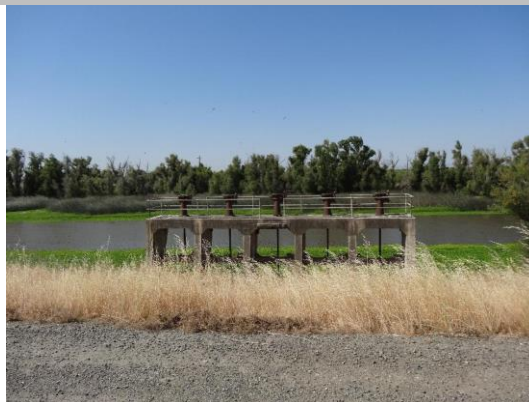
Photo 1 of 3 : UCIP\_SP\_2017\_37608\_68207.jpg

LM Start	<b>0.06</b>	Rating **	M	Issue No.	<b>38</b>
LM End	<b>0.06</b>	Issue Type +	Ma	Location *	N/A
Category	Supplemental		GPS Latitude/Longitude		
			Start	End	
Item	DWR UCIP LMA Responsibility		38.822897 °	38.822897 °	
			-121.797000 °	-121.797000 °	
DWR ID					
Comment Code					
Inspector Comment					
FS_ID:37608 DS_ID:17943 EP_NO: 9396 Repair Type: Non-Urgent Crossing Status: Found UCIP Comments: Need to contact owner to determine status of structure. Notes indicate crossing has been abandoned. Owner will need to coordinate with CVFPB and DWR inspector to determine how to properly abandon. FIELD_STRUCT_DESC: 1 of 5. Five 72-inch abandoned pipes or culvert through levee 31.6 feet below crown. Slide gates on both ends. (App. 9736-RD 108) Ramp on landward slope. (App.9396-RD). O&M Manual SAC 132; October 1959 FS Date: 6/10/2014

View of concrete structure visible on waterward side.

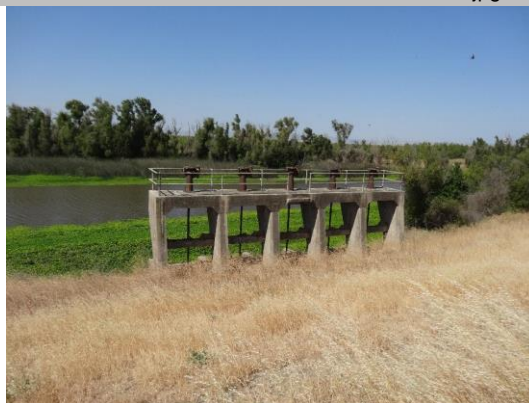
Photo 2 of 3 : UCIP\_SP\_2017\_37608\_68210.jpg

LM Start	0.06	Rating **	M	Issue No.	38 (cont)
LM End	0.06	Issue Type +	Ma	Location *	N/A
Category	Supplemental			GPS Latitude/Longitude	
				Start	End
Item	DWR UCIP LMA Responsibility			38.822897 °	38.822897 °
				-121.797000 °	-121.797000 °
DWR ID					
Comment Code					
Inspector Comment					
FS_ID:37608					
DS_ID:17943					
EP_NO: 9396					
Repair Type: Non-Urgent					
Crossing Status: Found					
UCIP Comments: Need to contact owner to determine status of structure. Notes indicate crossing has been abandoned. Owner will need to coordinate with CVFPB and DWR inspector to determine how to properly abandon.					
FIELD_STRUCT_DESC: 1 of 5. Five 72-inch abandoned pipes or culvert through levee 31.6 feet below crown. Slide gates on both ends. (App. 9736-RD 108) Ramp on landward slope. (App.9396-RD). O&M Manual SAC 132; October 1959					
FS Date: 6/10/2014

Dense vegetation on waterward side.

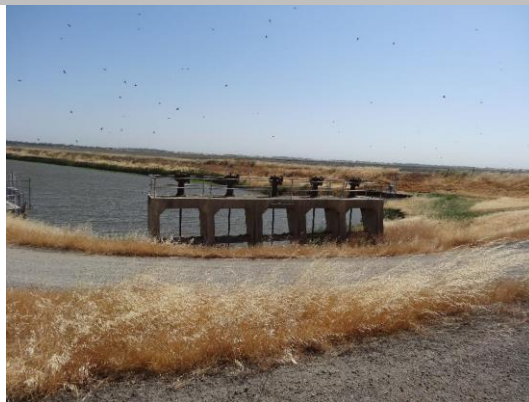
Photo 3 of 3 : UCIP\_SP\_2017\_37608\_68208.jpg

View of concrete structure visible on landward side.

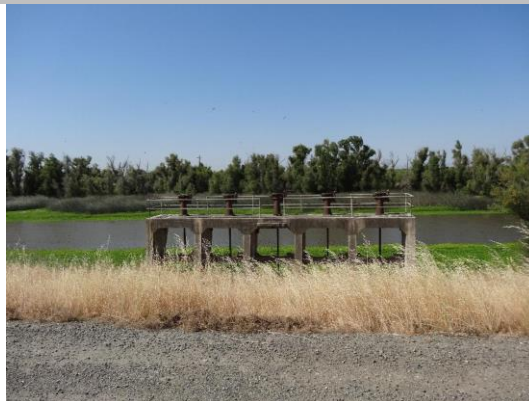
Photo 1 of 3 : UCIP\_SP\_2017\_37609\_68211.jpg

LM Start	0.06	Rating **	M	Issue No.	39
LM End	0.06	Issue Type +	Ma	Location *	N/A
Category	Supplemental			GPS Latitude/Longitude	
				Start	End
Item	DWR UCIP LMA Responsibility			38.822919 °	38.822919 °
				-121.797046 °	-121.797046 °
DWR ID					
Comment Code					
Inspector Comment					
FS_ID:37609					
DS_ID:22386					
EP_NO: 9396					
Repair Type: Non-Urgent					
Crossing Status: Found					
UCIP Comments: Need to contact owner to determine status of structure. Notes indicate crossing has been abandoned. Owner will need to coordinate with CVFPB and DWR inspector to determine how to properly abandon.					
FIELD_STRUCT_DESC: 2 of 5. Five 72-inch abandoned pipes or culvert through levee 31.6 feet below crown. Slide gates on both ends. (App. 9736-RD 108) Ramp on landward slope. (App.9396-RD). O&M Manual SAC 132; October 1959					
FS Date: 6/10/2014

Concrete structure located on waterward side.

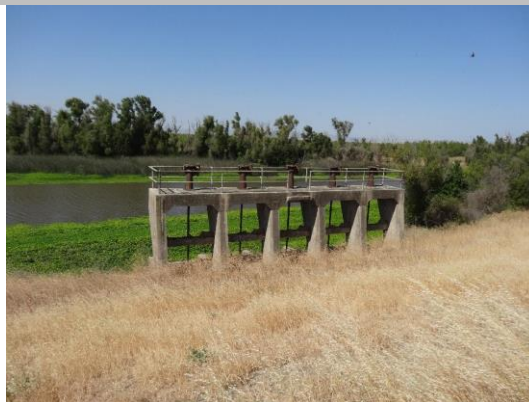
Photo 2 of 3 : UCIP\_SP\_2017\_37609\_68215.jpg

Dense vegetation covers the waterward slope.

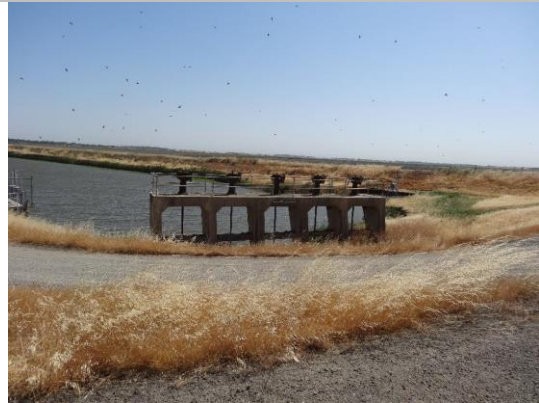
Photo 3 of 3 : UCIP\_SP\_2017\_37609\_68213.jpg

View of concrete structure located on landward side.

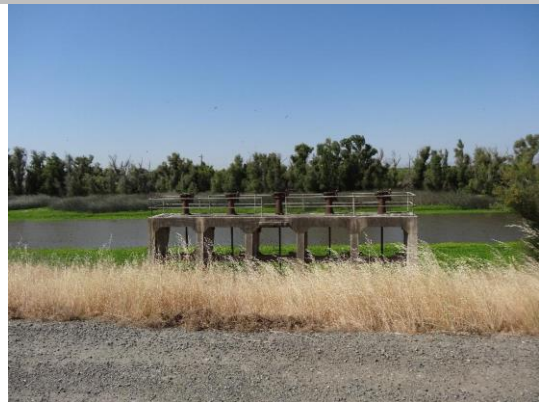
Photo 1 of 3 : UCIP\_SP\_2017\_37610\_68216.jpg

LM Start	0.06	Rating **	M	Issue No.	40
LM End	0.06	Issue Type +	Ma	Location *	N/A
Category	Supplemental			GPS Latitude/Longitude	
				Start	End
Item	DWR UCIP LMA Responsibility			38.822933 °	38.822933 °
				-121.797081 °	-121.797081 °
DWR ID					
Comment Code					
Inspector Comment					
FS_ID:37610					
DS_ID:22387					
EP_NO: 9396					
Repair Type: Non-Urgent					
Crossing Status: Found					
UCIP Comments: Need to contact owner to determine status of structure. Notes indicate crossing has been abandoned. Owner will need to coordinate with CVFPB and DWR inspector to determine how to properly abandon.					
FIELD_STRUCT_DESC: 3 of 5. Five 72-inch abandoned pipes or culvert through levee 31.6 feet below crown. Slide gates on both ends. (App. 9736-RD 108) Ramp on landward slope. (App.9396-RD). O&M Manual SAC 132; October 1959					
FS Date: 6/10/2014

Concrete structure located on waterward side.

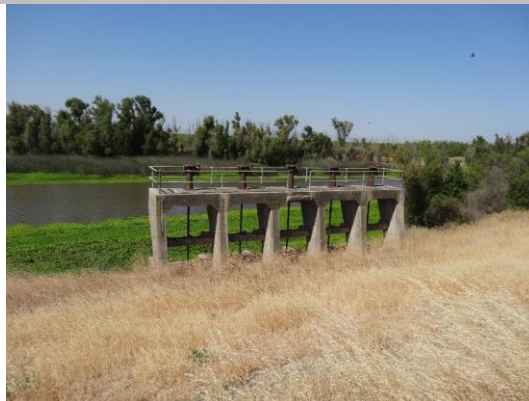
Photo 2 of 3 : UCIP\_SP\_2017\_37610\_68219.jpg

Dense vegetation covers waterward side slope.

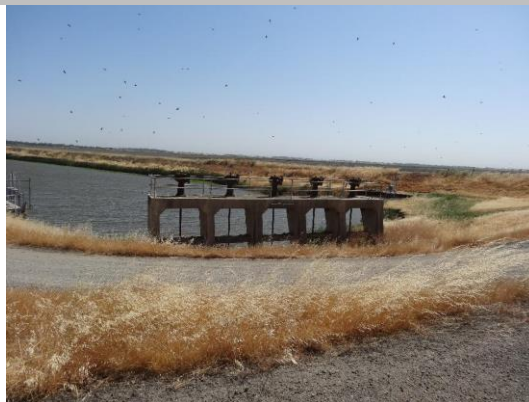
Photo 3 of 3 : UCIP\_SP\_2017\_37610\_68217.jpg

Concrete structure located on landward side.

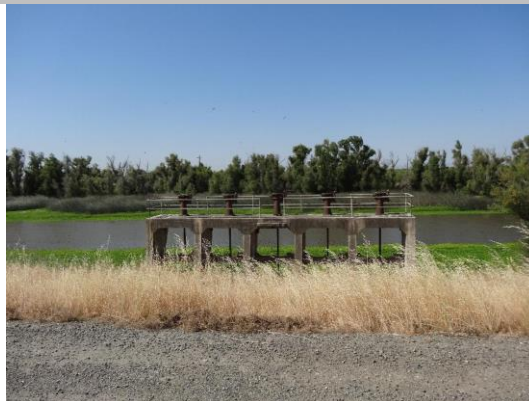
Photo 1 of 3 : UCIP\_SP\_2017\_37611\_68220.jpg

LM Start	0.06	Rating **	M	Issue No.	41
LM End	0.06	Issue Type +	Ma	Location *	N/A
Category	Supplemental			GPS Latitude/Longitude	
				Start	End
Item	DWR UCIP LMA Responsibility			38.822897 °	38.822897 °
				-121.797000 °	-121.797000 °
DWR ID					
Comment Code					
Inspector Comment					
FS_ID:37611					
DS_ID:22388					
EP_NO: 9396					
Repair Type: Non-Urgent					
Crossing Status: Found					
UCIP Comments: Need to contact owner to determine status of structure. Notes indicate crossing has been abandoned. Owner will need to coordinate with CVFPB and DWR inspector to determine how to properly abandon.					
FIELD_STRUCT_DESC: 4 of 5. Five 72-inch abandoned pipes or culvert through levee 31.6 feet below crown. Slide gates on both ends. (App. 9736-RD 108) Ramp on landward slope. (App.9396-RD). O&M Manual SAC 132; October 1959					
FS Date: 6/10/2014

Concrete structure located on waterward side.

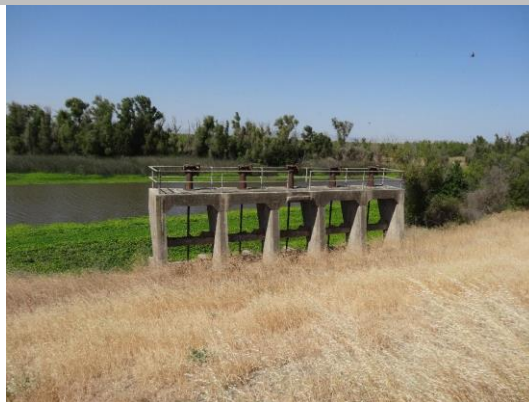
Photo 2 of 3 : UCIP\_SP\_2017\_37611\_68224.jpg

Waterward slope covered by dense vegetation.

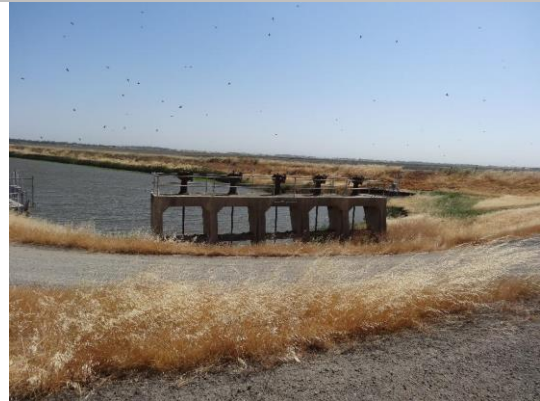
Photo 3 of 3 : UCIP\_SP\_2017\_37611\_68222.jpg

Concrete structure visible on landward side.

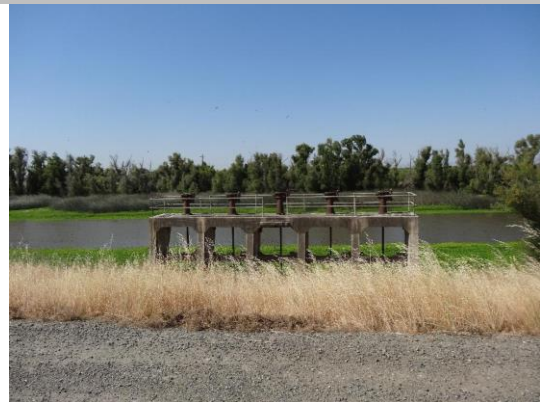
Photo 1 of 3 : UCIP\_SP\_2017\_37607\_68203.jpg

LM Start	0.07	Rating **	M	Issue No.	42
LM End	0.07	Issue Type +	Ma	Location *	N/A
Category	Supplemental			GPS Latitude/Longitude	
				Start	End
Item	DWR UCIP LMA Responsibility			38.822954 °	38.822954 °
				-121.797135 °	-121.797135 °
DWR ID					
Comment Code					
Inspector Comment					
FS_ID:37607					
DS_ID:22389					
EP_NO: 9396					
Repair Type: Non-Urgent					
Crossing Status: Found					
UCIP Comments: Need to contact owner to determine status of structure. Notes indicate crossing has been abandoned. Owner will need to coordinate with CVFPB and DWR inspector to determine how to properly abandon.					
FIELD_STRUCT_DESC: 5 of 5. Five 72-inch abandoned pipes or culvert through levee 31.6 feet below crown. Slide gates on both ends. (App. 9736-RD 108) Ramp on landward slope. (App.9396-RD). O&M Manual SAC 132; October 1959					
FS Date: 6/10/2014

Concrete structure located on waterward side.

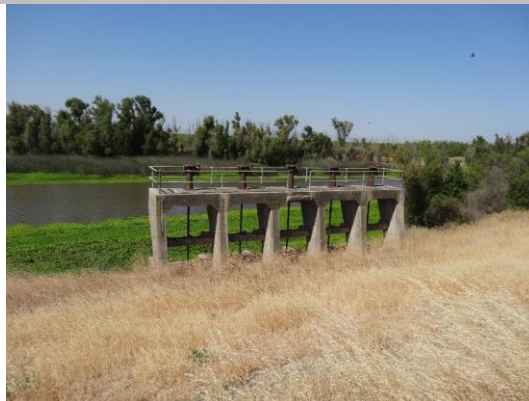
Photo 2 of 3 : UCIP\_SP\_2017\_37607\_68206.jpg

Waterward slope covered by dense vegetation.

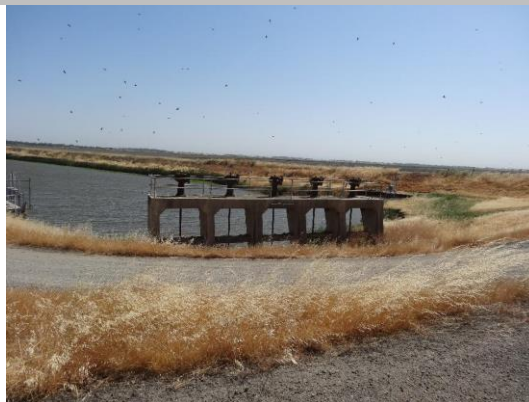
Photo 3 of 3 : UCIP\_SP\_2017\_37607\_68204.jpg

Concrete structure located on landward side.

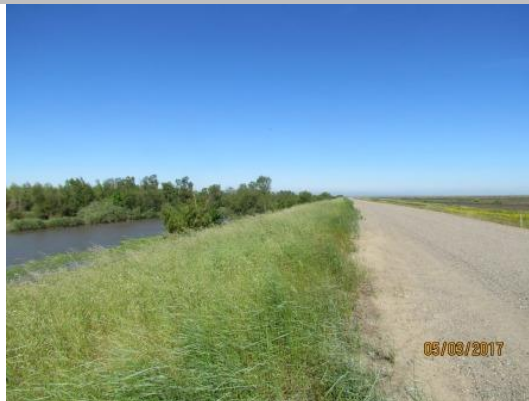
Photo 1 of 1 : SP\_2017\_RD0108\_203\_19\_20170503\_00038.jpg

Tall grass on waterside levee slope, blocking visibility/ Spring 2017.

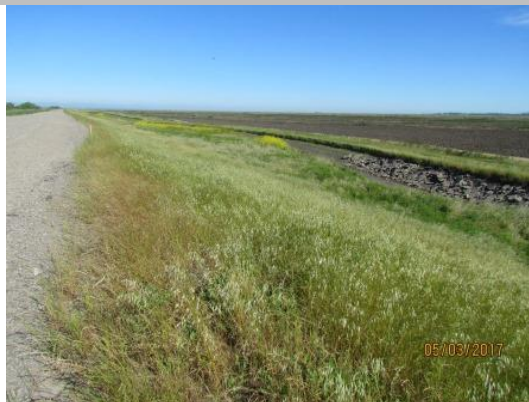
Photo 1 of 1 : SP\_2017\_RD0108\_203\_24\_20170503\_00039.jpg

LM Start	0.10	Rating **	U	Issue No.	24
LM End	16.25	Issue Type +	Ma	Location *	LS
Category	Earthen Levee			GPS Latitude/Longitude	
				Start	End
Item	Vegetation			38.823151 °	38.984452 °
				-121.797639 °	-121.947592 °
DWR ID	DWR_RD0108_01_s_2017_24				
Comment Code					
V1 : Control annual grass and weeds on the levee slopes and easements.					
Inspector Comment

Tall grass on landside levee slope, blocking visibility. Spring 2017.

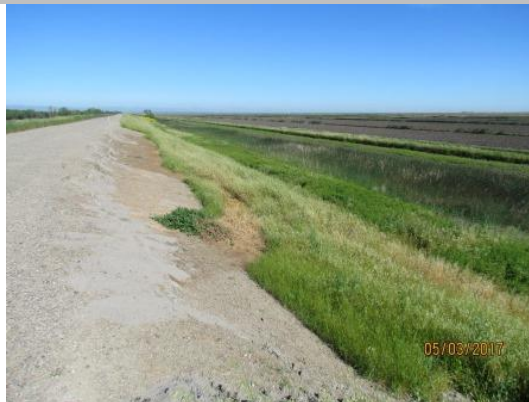
Photo 1 of 1 : SP\_2017\_RD0108\_203\_25\_20170503\_00040.jpg

LM Start	1.48	Rating **	M	Issue No.	25
LM End	1.51	Issue Type +	Ma	Location *	LS
Category	Earthen Levee			GPS Latitude/Longitude	
				Start	End
Item	Slope Stability			38.830839 °	38.831009 °
				-121.821321 °	-121.821821 °
DWR ID	DWR_RD0108_01_s_2017_25				
Comment Code					
S1 : Repair slope instability.					
Inspector Comment					
150' sloughing section on landside levee slope. District will attempt to repair this site without USACE assistance.

View of sloughing on landside slope. Spring 2017.

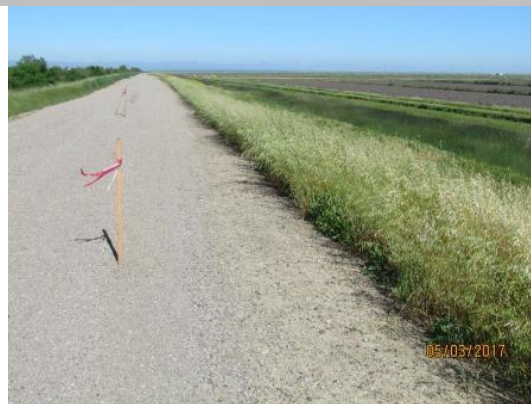
Photo 1 of 1 : SP\_2017\_RD0108\_203\_27\_20170503\_00041.jpg

LM Start	1.93	Rating **	M	Issue No.	27
LM End	1.97	Issue Type +	Ma	Location *	LS
Category	Earthen Levee			GPS Latitude/Longitude	
				Start	End
Item	Slope Stability			38.833274 °	38.833486 °
				-121.829056 °	-121.829696 °
DWR ID	DWR_RD0108_01_s_2017_27				
Comment Code					
S1 : Repair slope instability.					
Inspector Comment					
150' sloughing section on crown and landside levee slope. District will attempt to repair without USACE assistance.

View of sloughing on landside slope. Spring 2017.

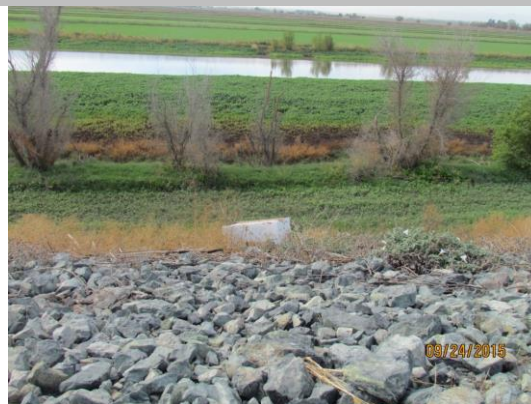
Photo 1 of 1 : SP\_2017\_RD0108\_203\_23\_20170320\_00010.jpg

LM Start	3.65	Rating **	M	Issue No.	23
LM End	3.65	Issue Type +	Ma	Location *	WS
Category	Earthen Levee			GPS Latitude/Longitude	
				Start	End
Item	Encroachments			38.842620 °	38.842620 °
				-121.858732 °	-121.858732 °
DWR ID	DWR_RD0108_01_f_2015_23				
Comment Code					
DE : Debris					
Inspector Comment

View of the debris on the waterward side of the levee. Fall 2015.

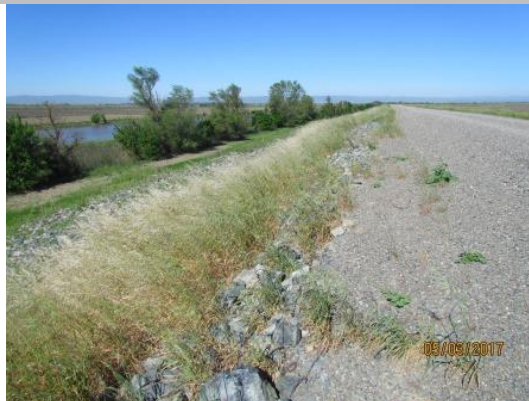
Photo 1 of 1 : SP\_2017\_RD0108\_203\_28\_20170503\_00042.jpg

Tall grass on waterside levee slope, blocking visibility. Spring 2017.

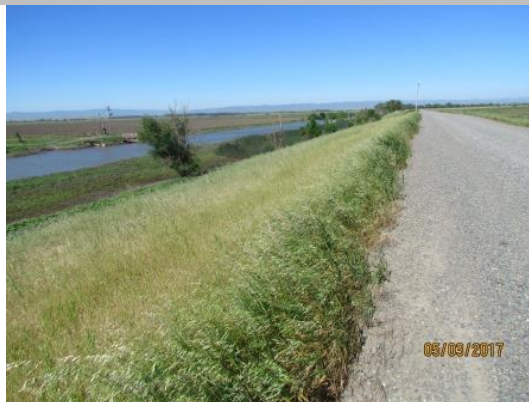
Photo 1 of 1 : SP\_2017\_RD0108\_203\_30\_20170503\_00043.jpg

LM Start	4.56	Rating **	U	Issue No.	30
LM End	20.64	Issue Type +	Ma	Location *	WS
Category	Earthen Levee			GPS Latitude/Longitude	
				Start	End
Item	Vegetation			38.844511 °	39.033933 °
				-121.875348 °	-121.993293 °
DWR ID	DWR_RD0108_01_s_2017_30				
Comment Code					
V1 : Control annual grass and weeds on the levee slopes and easements.					
Inspector Comment

Tall grass on waterside levee slope, blocking visibility. Spring 2017.

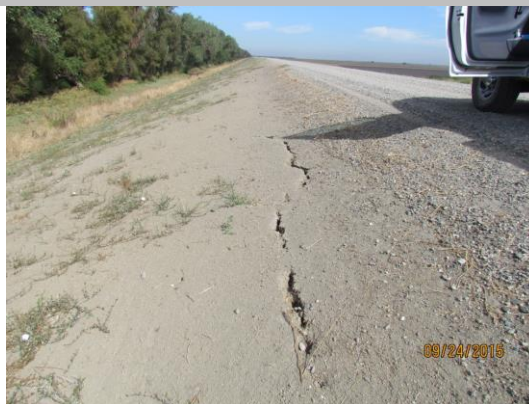
Photo 1 of 1 : SP\_2017\_RD0108\_203\_26\_20170320\_00011.jpg

LM Start	8.27	Rating **	A/W	Issue No.	26
LM End	8.27	Issue Type +	Ma	Location *	WS
Category	Earthen Levee			GPS Latitude/Longitude	
				Start	End
Item	Cracking			38.882595 °	38.882595 °
				-121.914669 °	-121.914669 °
DWR ID	DWR_RD0108_01_f_2015_26				
Comment Code					
CR1 : Monitor and have inspected by geotechnical engineer.					
Inspector Comment					
Cracking still visible, but appears to have closed up during winter season. Recommend monitoring.

View of the crack on the waterward side of the levee looking upstream.  
Suggest monitoring the crack. Fall 2015.

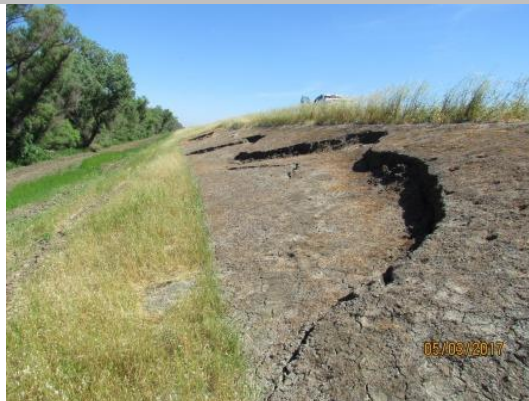
Photo 1 of 1 : SP\_2017\_RD0108\_203\_10\_20170503\_00044.jpg

LM Start	9.17	Rating **	U	Issue No.	10
LM End	9.20	Issue Type +	Ma	Location *	WS
Category	Earthen Levee			GPS Latitude/Longitude	
				Start	End
Item	Slope Stability			38.895605 °	38.896086 °
				-121.914645 °	-121.914646 °
DWR ID	DWR_RD0108_01_s_2017_10				
Comment Code					
S1 : Repair slope instability.					
Inspector Comment					
200' section of multiple sloughs. District submitted request for PL 84-99 assistance.

View of sloughing on waterside slope. Spring 2017.

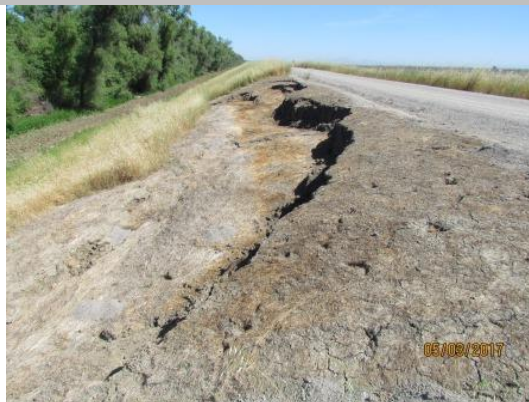
Photo 1 of 1 : SP\_2017\_RD0108\_203\_31\_20170503\_00045.jpg

LM Start	9.30	Rating **	M	Issue No.	31
LM End	9.30	Issue Type +	Ma	Location *	WS
Category	Earthen Levee			GPS Latitude/Longitude	
				Start	End
Item	Slope Stability			38.897494 °	38.897494 °
				-121.914680 °	-121.914680 °
DWR ID	DWR_RD0108_01_s_2017_31				
Comment Code					
S1 : Repair slope instability.					
Inspector Comment					
100' sloughing section on waterside slope. District submitted application for PL 84-99 assistance.

View of sloughing on waterside slope. Spring 2017.

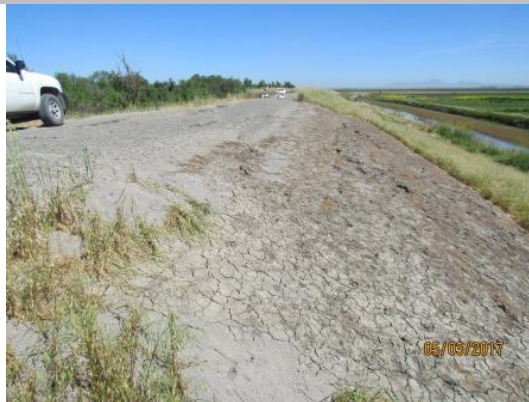
Photo 1 of 2 : SP\_2017\_RD0108\_203\_32\_20170503\_00046.jpg

LM Start	12.68	Rating **	M	Issue No.	32
LM End	12.71	Issue Type +	Ma	Location *	LS
Category	Earthen Levee			GPS Latitude/Longitude	
				Start	End
Item	Slope Stability			38.945376 °	38.945719 °
				-121.906768 °	-121.906773 °
DWR ID	DWR_RD0108_01_s_2017_32				
Comment Code					
S1 : Repair slope instability.					
Inspector Comment					
150' sloughing section on crown and landside slope. District submitted an application for PL 84-99 assistance.

View of sloughing on crown and slope. Spring 2017.

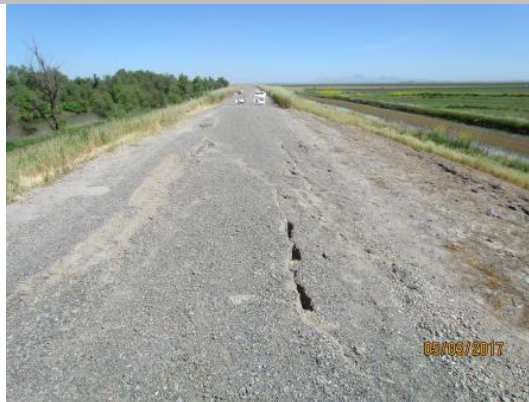
Photo 2 of 2 : SP\_2017\_RD0108\_203\_32\_20170503\_00047.jpg

Additional view of sloughing. Spring 2017.

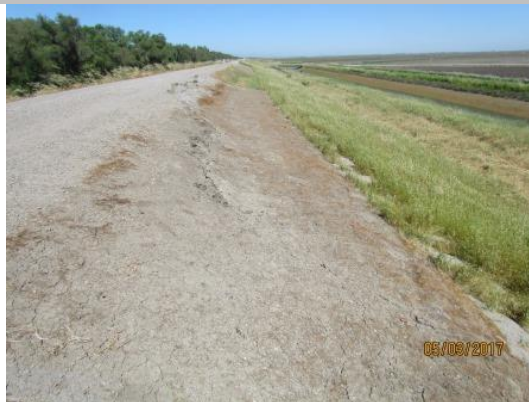
Photo 1 of 1 : SP\_2017\_RD0108\_203\_33\_20170503\_00048.jpg

LM Start	14.47	Rating **	U	Issue No.	33
LM End	14.55	Issue Type +	Ma	Location *	LS
Category	Earthen Levee			GPS Latitude/Longitude	
				Start	End
Item	Slope Stability			38.967062 °	38.967784 °
				-121.923113 °	-121.924148 °
DWR ID	DWR_RD0108_01_s_2017_33				
Comment Code					
S1 : Repair slope instability.					
Inspector Comment					
400' sloughing section on landside slope. District submitted an application for PL 84-99 assistance.

View of sloughing on landside slope. Spring 2017.

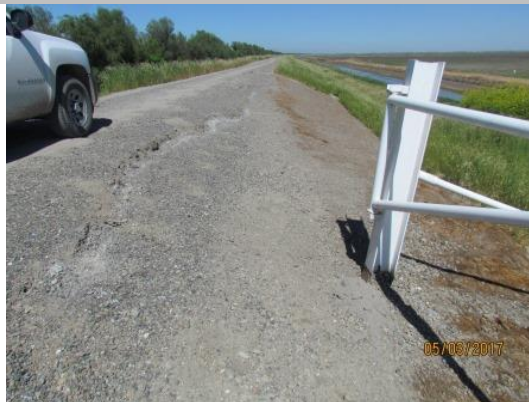
Photo 1 of 1 : SP\_2017\_RD0108\_203\_21\_20170503\_00049.jpg

LM Start	14.76	Rating **	M	Issue No.	21
LM End	14.76	Issue Type +	Ma	Location *	LS
Category	Earthen Levee			GPS Latitude/Longitude	
				Start	End
Item	Slope Stability			38.969852 °	38.969852 °
				-121.927023 °	-121.927023 °
DWR ID	DWR_RD0108_01_s_2017_21				
Comment Code					
S1 : Repair slope instability.					
Inspector Comment					
100' slough section on landside slope. District will repair without PL 84-99 assistance.

View of sloughing on landside slope. Spring 2017.

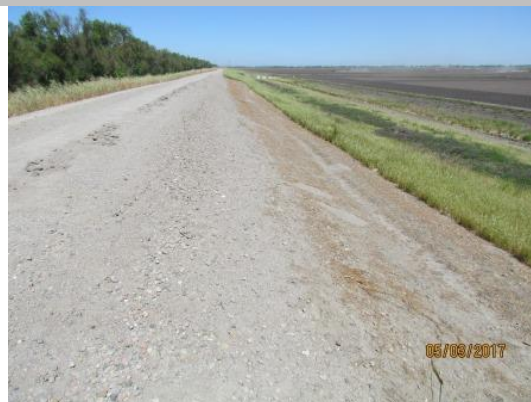
Photo 1 of 1 : SP\_2017\_RD0108\_203\_35\_20170503\_00050.jpg

LM Start	17.26	Rating **	U	Issue No.	35
LM End	17.31	Issue Type +	Ma	Location *	LS
Category	Earthen Levee			GPS Latitude/Longitude	
				Start	End
Item	Slope Stability			38.995293 °	38.995785 °
				-121.960200 °	-121.960776 °
DWR ID	DWR_RD0108_01_s_2017_35				
Comment Code					
S1 : Repair slope instability.					
Inspector Comment					
200' sloughing section on landside slope. District submitted an application for PL 84-99 assistance.

View of sloughing on landside slope. Spring 2017.

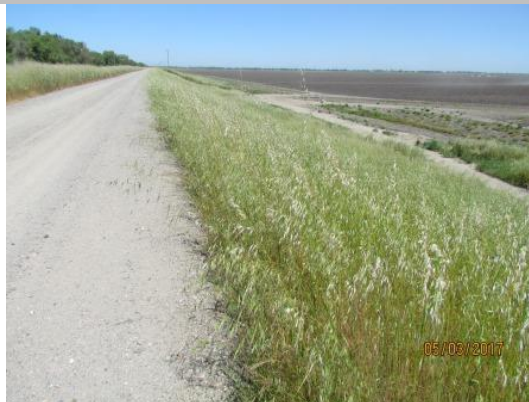
Photo 1 of 1 : SP\_2017\_RD0108\_203\_36\_20170503\_00051.jpg

Tall grass on landside levee slope, blocking visibility. Spring 2017.

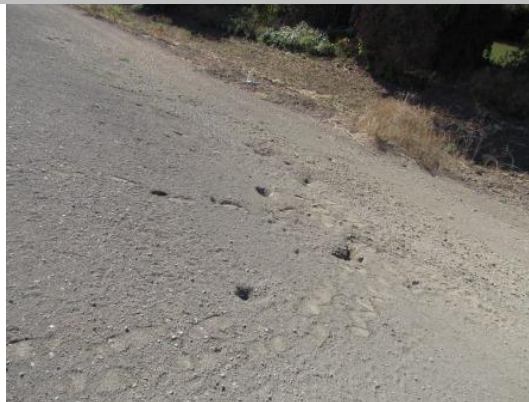
Photo 1 of 2 : SP\_2017\_RD0108\_203\_29\_20170320\_00012.jpg

LM Start	18.24	Rating **	M	Issue No.	29
LM End	18.24	Issue Type +	Ma	Location *	WS
Category	Earthen Levee			GPS Latitude/Longitude	
				Start	End
Item	Animal Control			39.005766 °	39.005766 °
				-121.972346 °	-121.972346 °
DWR ID	DWR_RD0108_01_f_2015_29				
Comment Code					
A3 : No rodents visible, but rodent burrows visible; need to backfill and compact or grout burrows.					
Inspector Comment

Updated view of a site with rodent activity. Fall 2016 inspection.

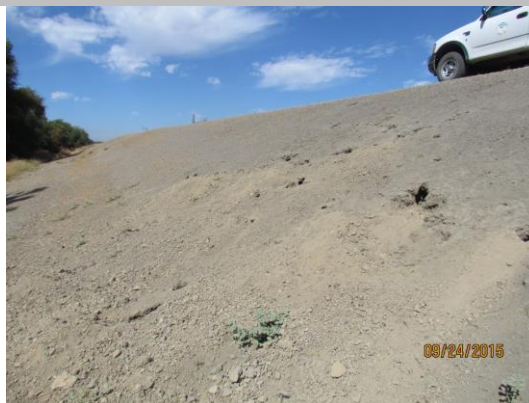
Photo 2 of 2 : SP\_2017\_RD0108\_203\_29\_20170320\_00013.jpg

View of the animal hole on the waterward side of the levee looking upstream. Fall 2015.

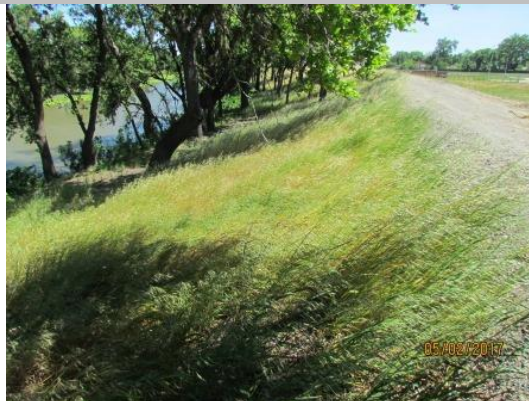
Photo 1 of 1 : SP\_2017\_RD0108\_590\_2\_20170502\_00006.jpg

Tall grass on waterside levee slope, blocking visibility. Spring 2017.

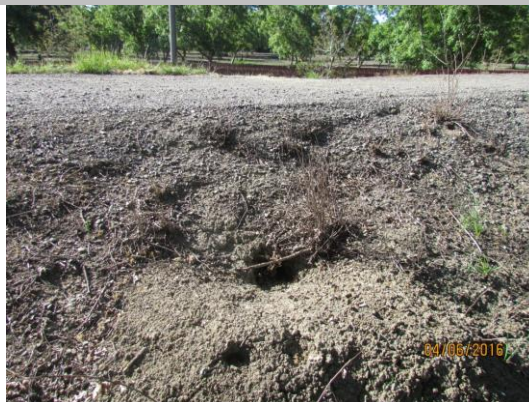
Photo 1 of 3 : SP\_2017\_RD0108\_590\_6\_20170320\_00002.jpg

Mound next to rodent hole is more than 2 cubic feet of material.

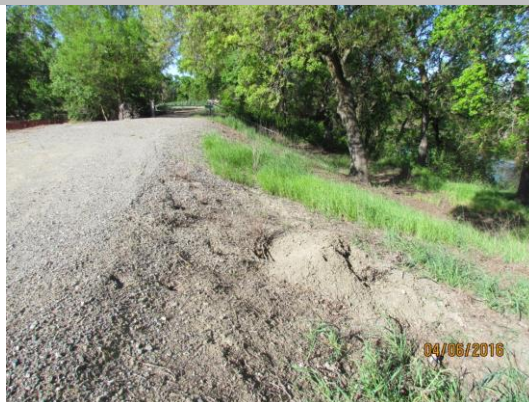
Photo 2 of 3 : SP\_2017\_RD0108\_590\_6\_20170320\_00003.jpg

Perspective view of the rodent hole on the waterward side of the levee looking upstream. Spring 2016.

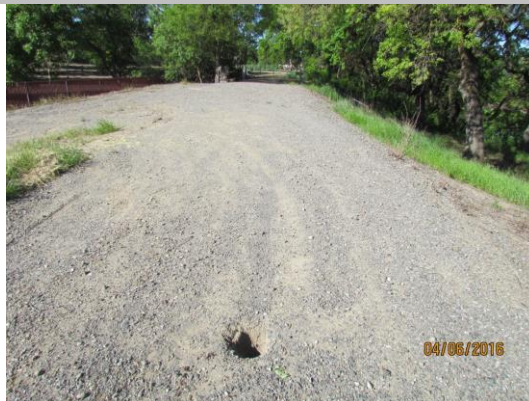
Photo 3 of 3 : SP\_2017\_RD0108\_590\_6\_20170320\_00004.jpg

Another hole is on top of the crown. Spring 2016.

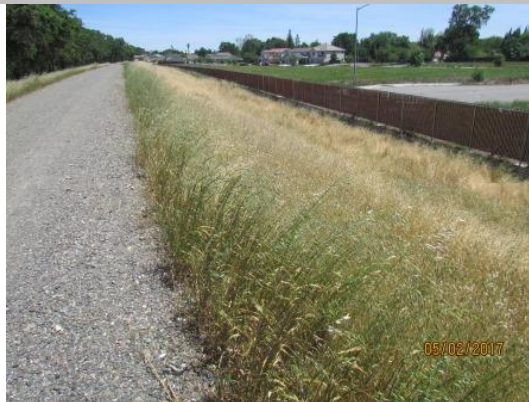
Photo 1 of 1 : SP\_2017\_RD0108\_590\_3\_20170502\_00007.jpg

Tall grass on landside levee slope, blocking visibility. Spring 2017.
